LEBANON 044/103

I-89 SB over CONNECTICUT RIVER, NECRR

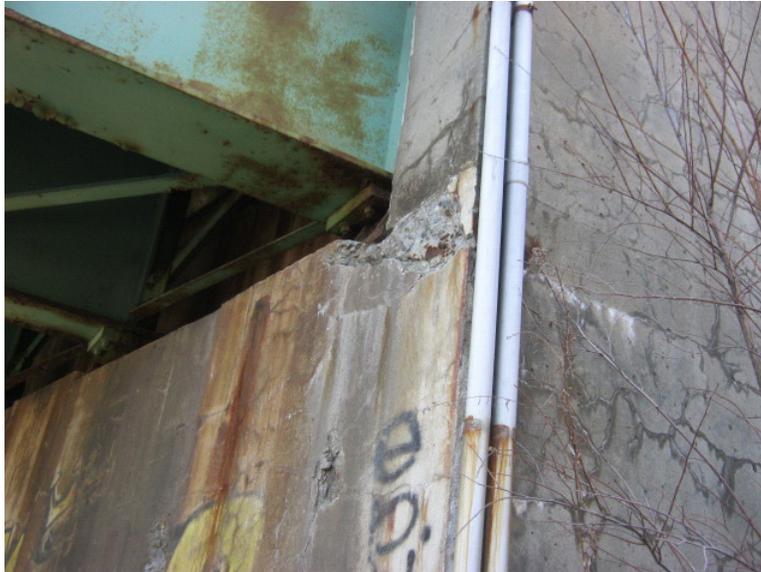
B546 21

SPALL AT NORTHEAST
ABUTMENT

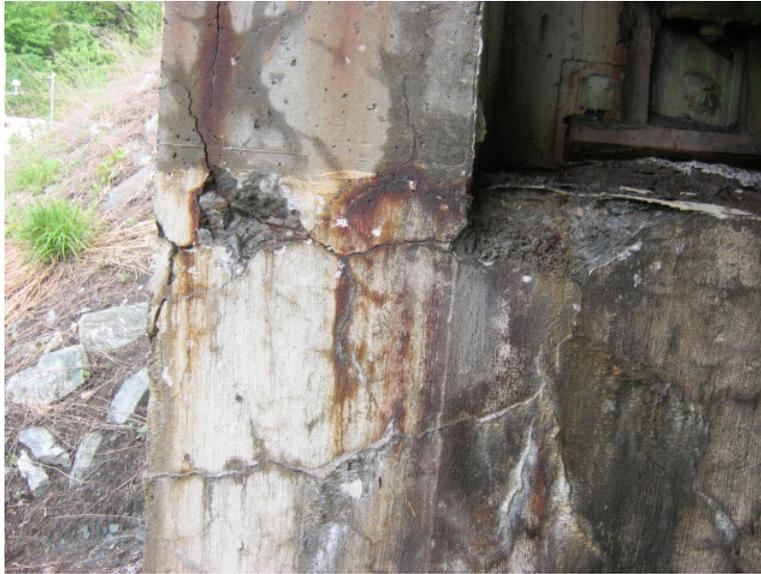
B531 34

CRACKS, SPALLS, HOLLOW
SOUNDING, NORTH
ABUTMENT WEST END.

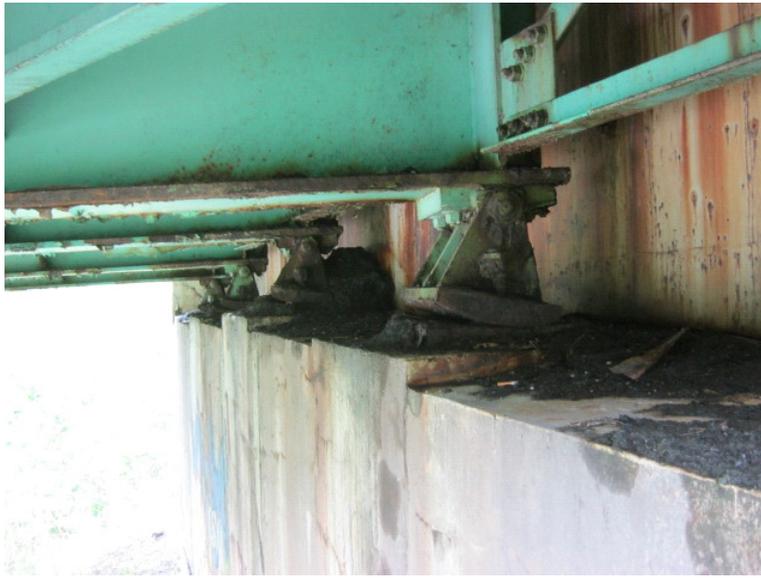
B531 35

BEARINGS # 1 - 4, NORTH
ABUTMENT.

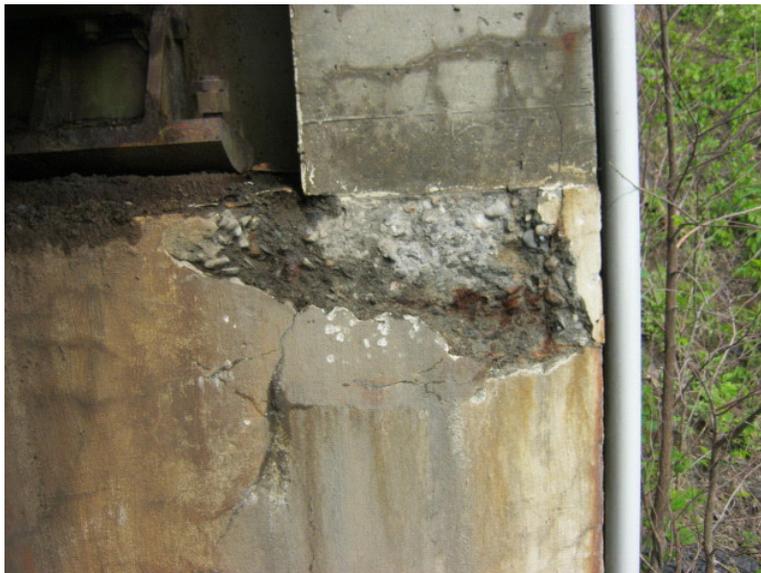
B531 36

SPALL AT EAST END OF
NORTH ABUTMENT.

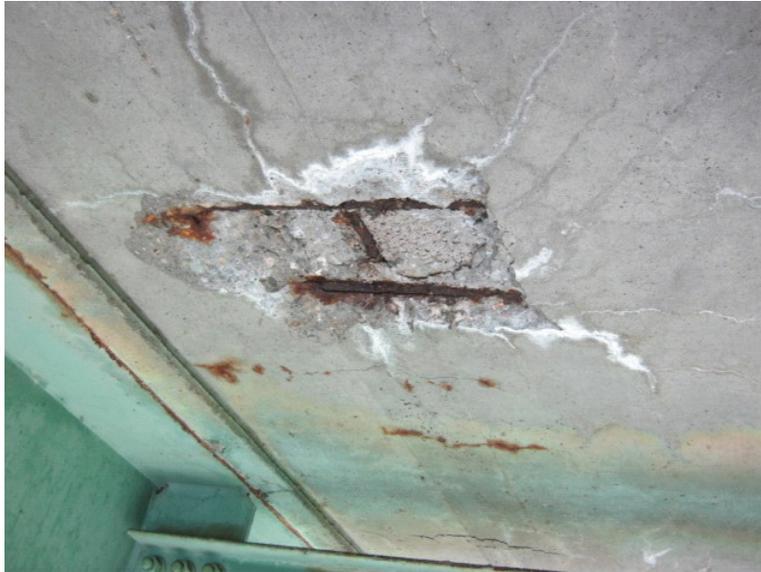
B531 37

SPALL WITH REBAR
EXPOSED, BAY # 3, SPAN #
6.

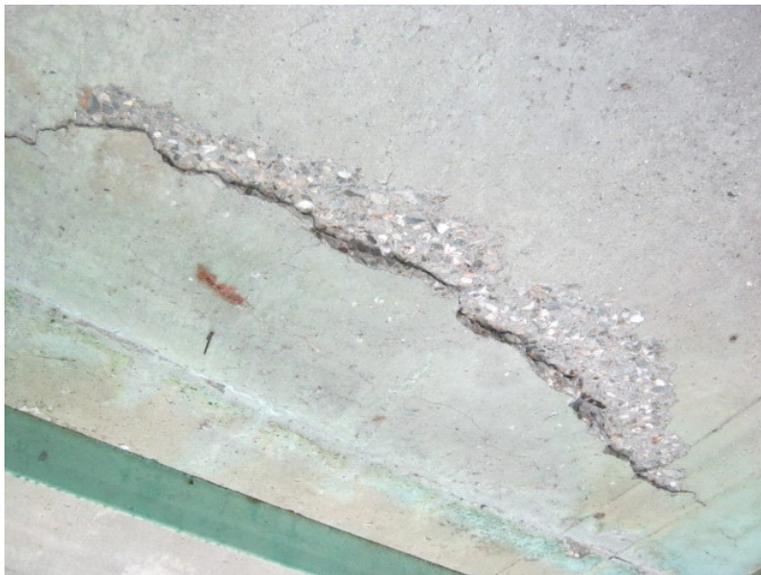
B531 38

DELAMINATION, SPALL, BAY
2, SPAN # 6.

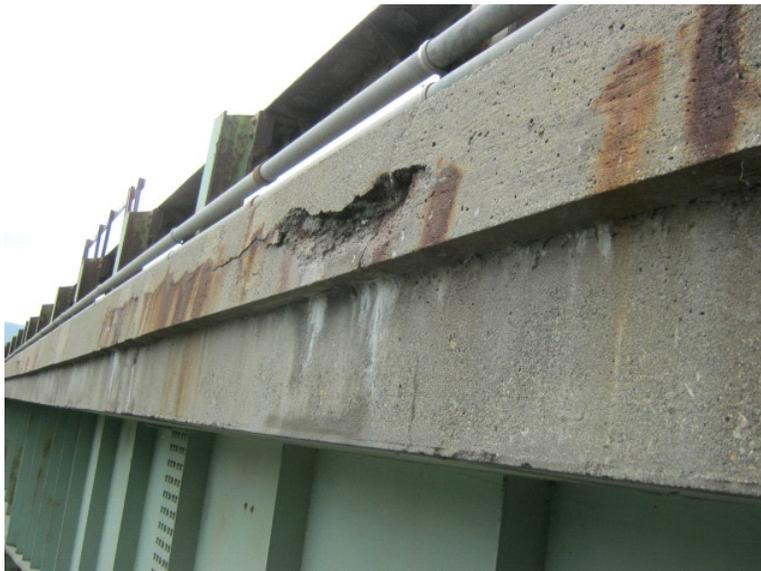
B531 39

CRACKS, RUST STAINS,
SPALL AT EAST CURB
FASCIA.

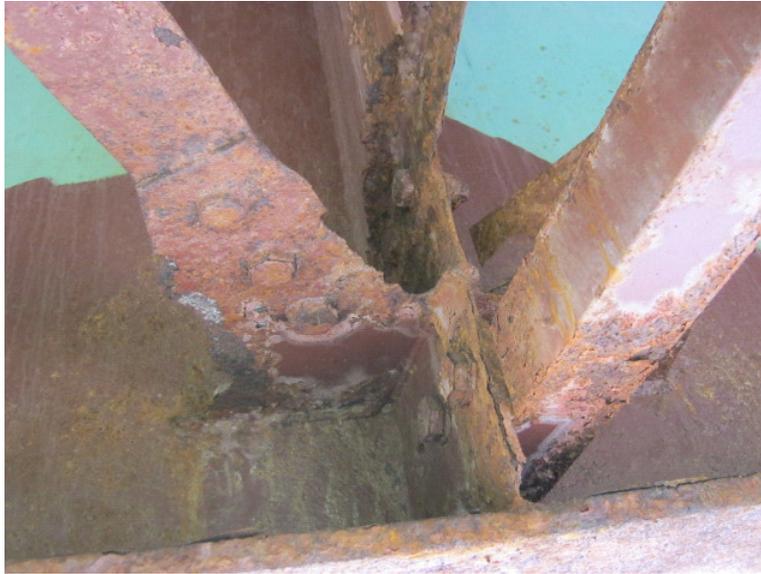
B531 40

RUST AND SCALE AT
GIRDER # 5 UNDER RELIEF
JOINT, SPAN # 4.

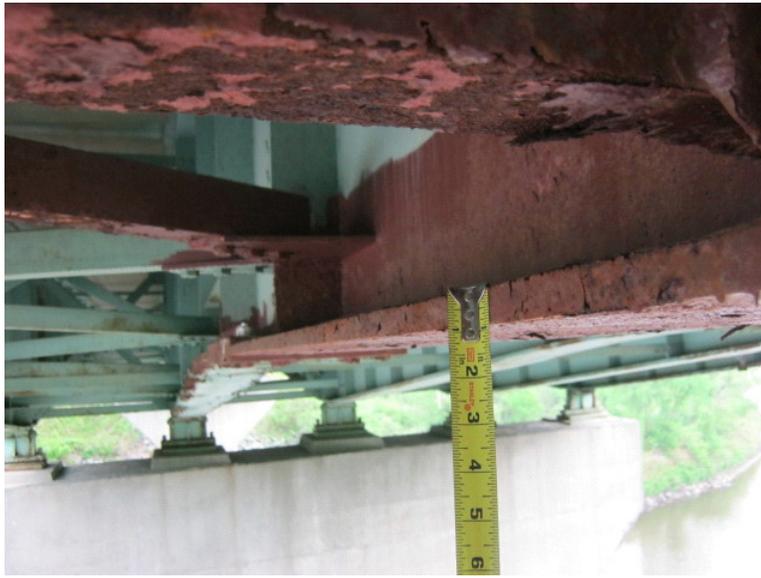
B531 41

7/8" REMAINING, GIRDER # 4
UNDER RELIEF JOINT, SPAN
3.

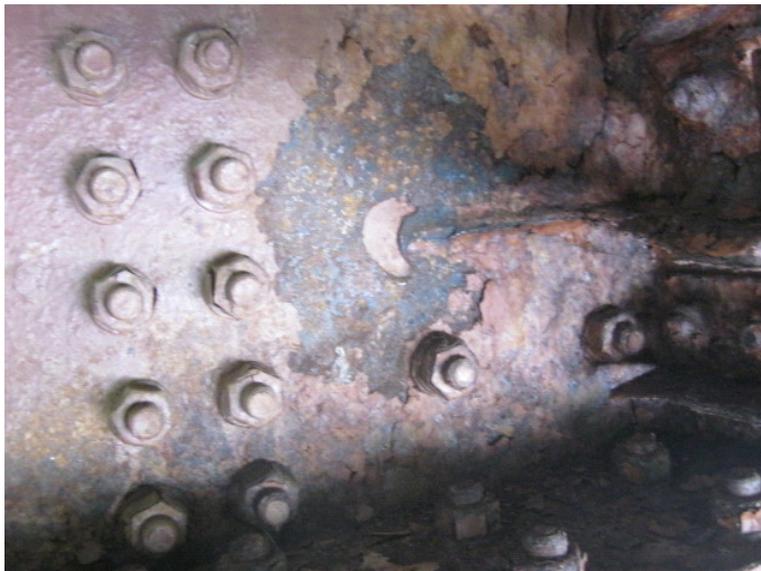
B531 42

GIRDER # 1 REPAIR UNDER
RELIEF JOINT, SPAN # 3.

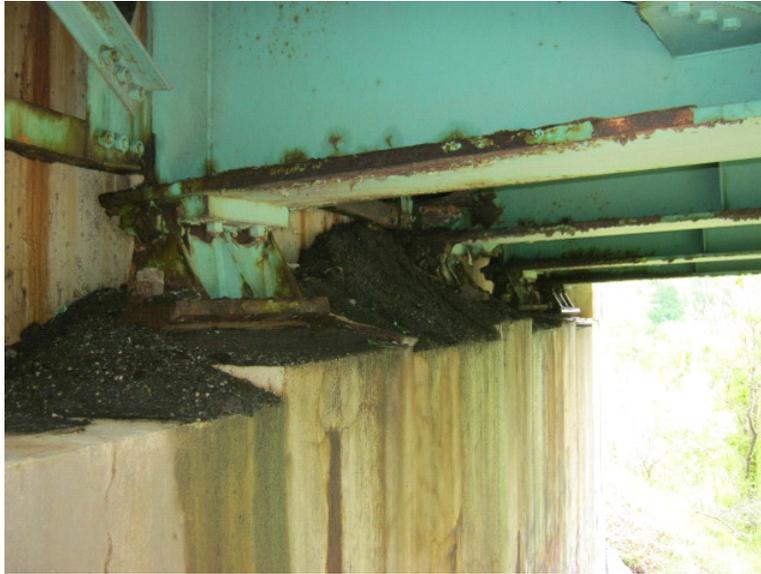
B531 43

BEARINGS AT SOUTH
ABUTMENT.

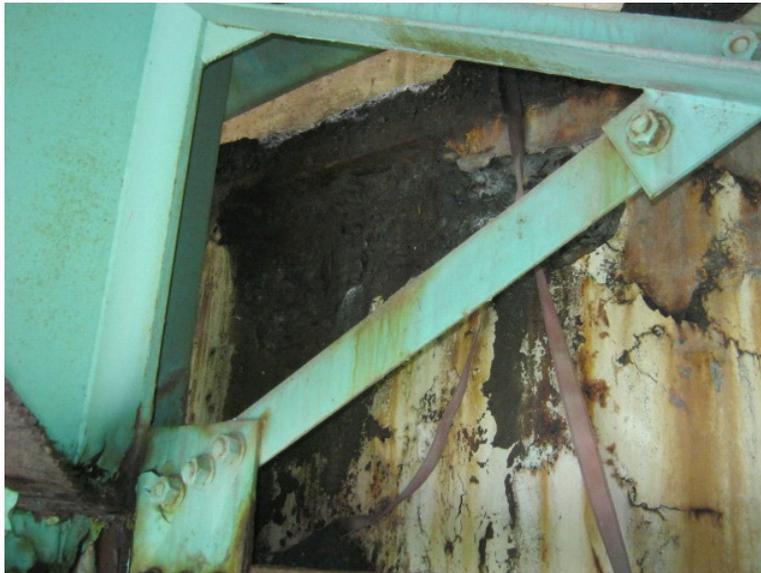
B531 44

SOUTH BACKWALL
SPALLED BEHIND GIRDER #
3.

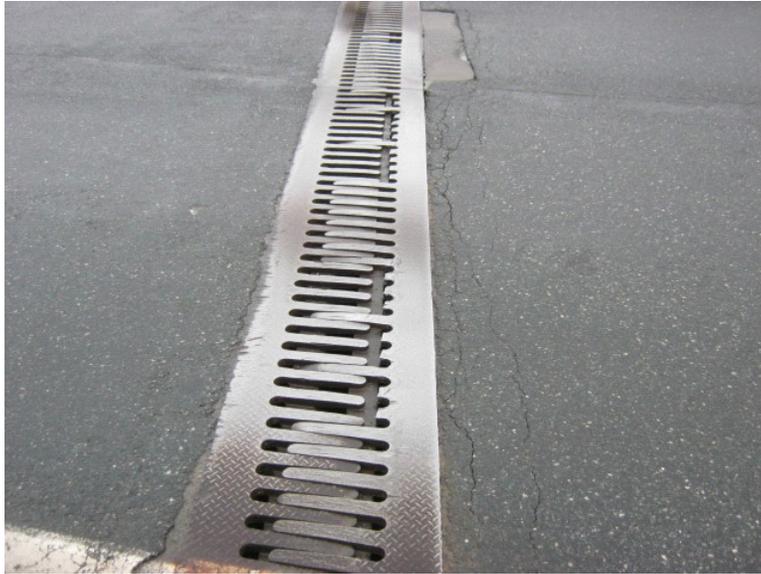
B518 02

SOUTH JOINT.

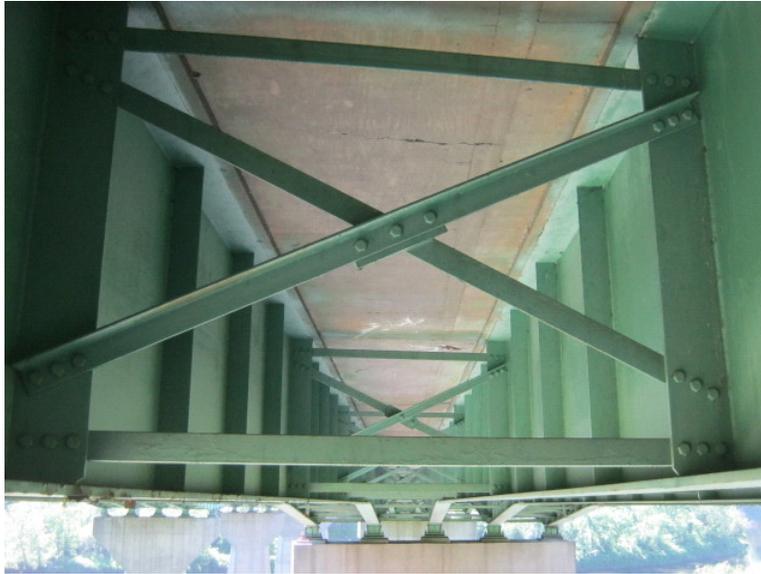
B500 67

SPALL IN SPAN 6 IN BAY 3.

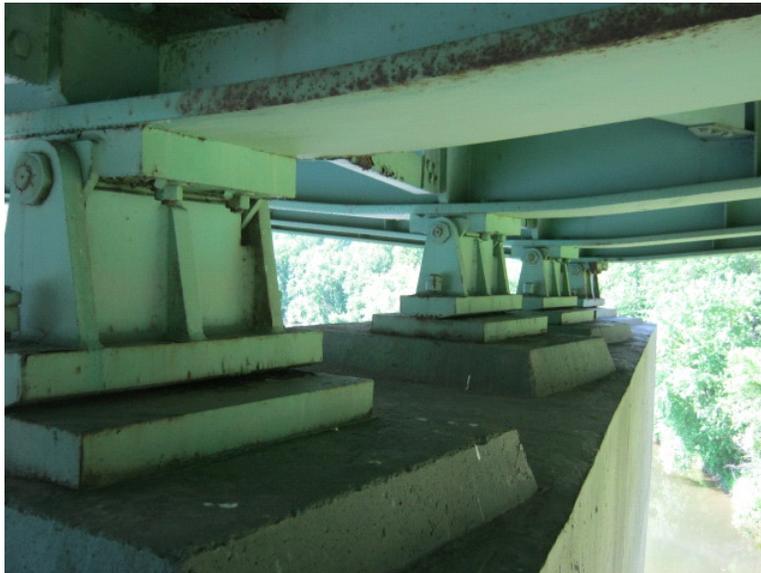
B500 68

BEARINGS AT PIER 4.

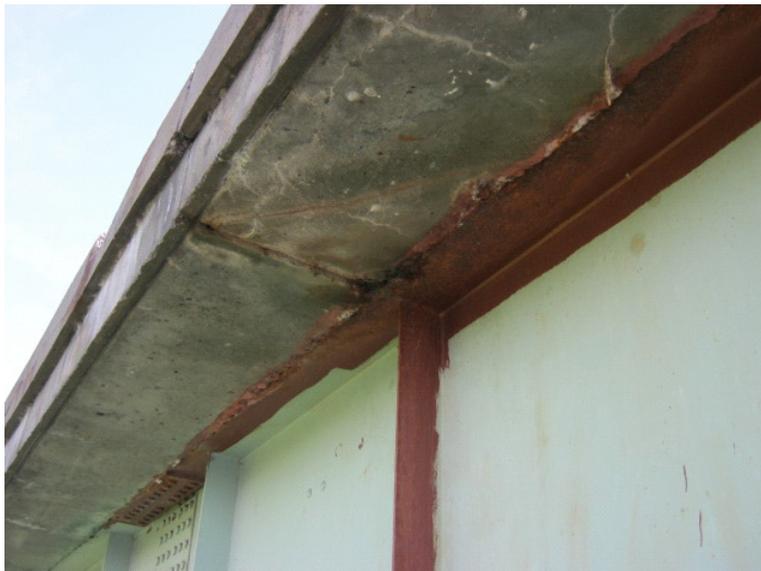
B500 69

JOINT LEAKING AT SPAN 4 EXTERIOR.

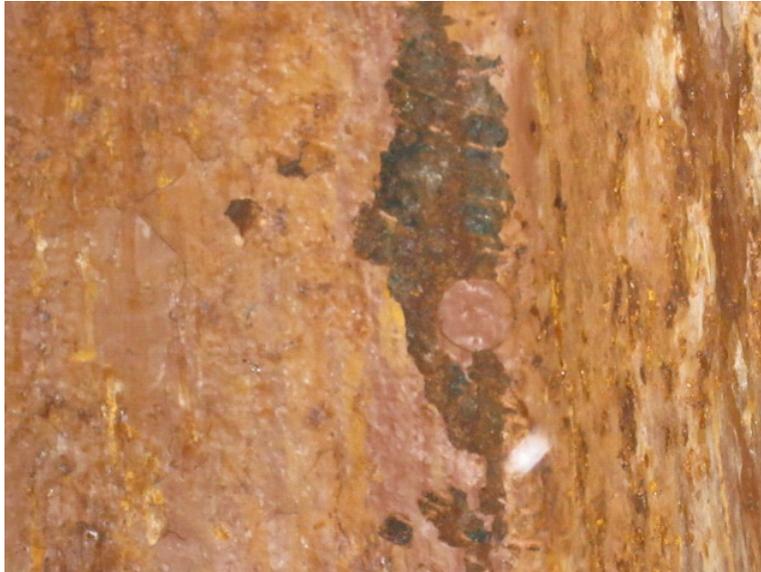
B500 70

PATCHED AREA UNDER
JOINT AT SPAN 3, NO
CHANGE IN CRACK.

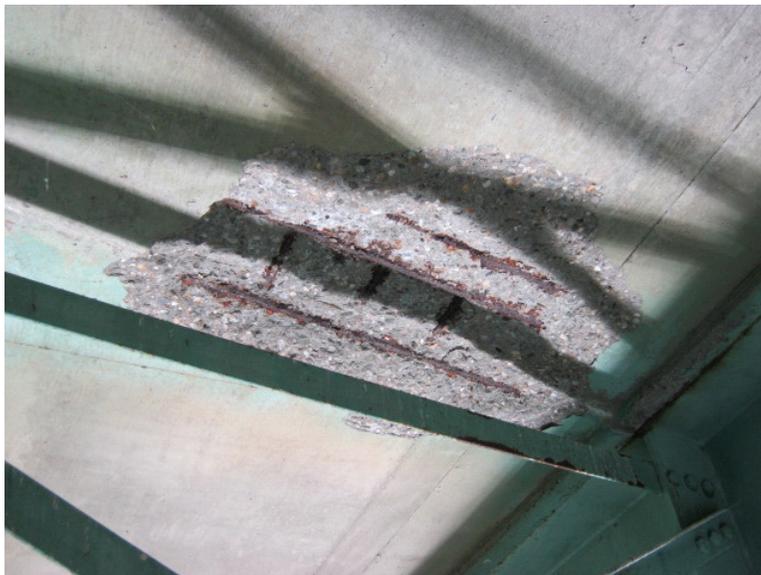
B500 71

LARGE SPALL 3'X4' X 4"
DEEP, IN SPAN 2 BAY 2.

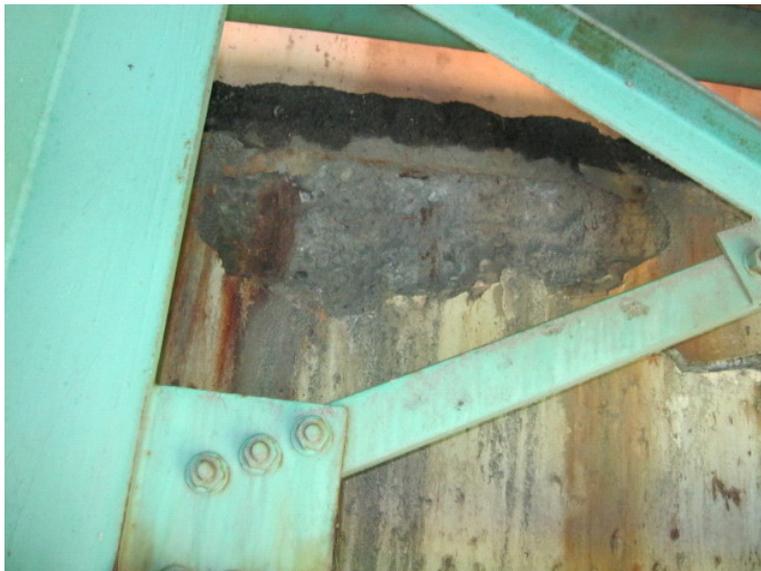
B500 72

SPALL IN SOUTH
ABUTMENT.

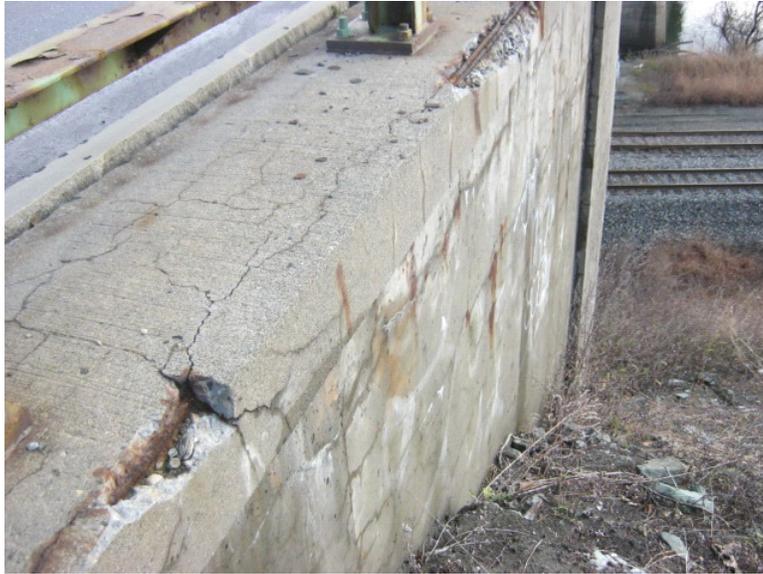
B486 44

CRACKS AND SPALLS AT
NORTHWEST WING.

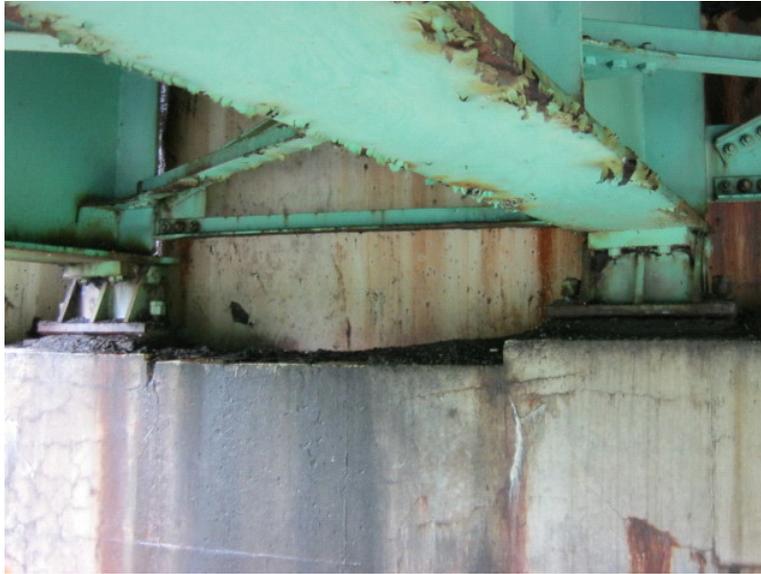
B467 01

BEARINGS 1 AND 2 AT
NORTH ABUTMENT

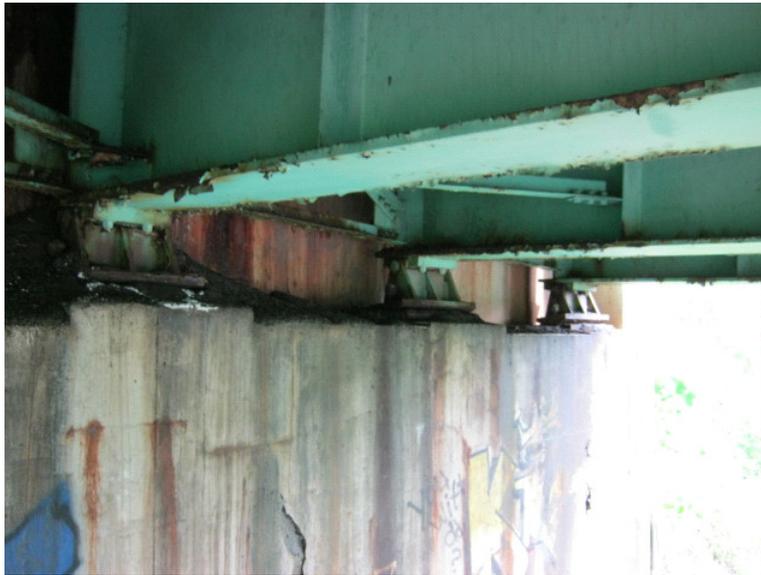
B467 02

BEARINGS 3,4 AND 5 AT
NORTH ABUTMENT

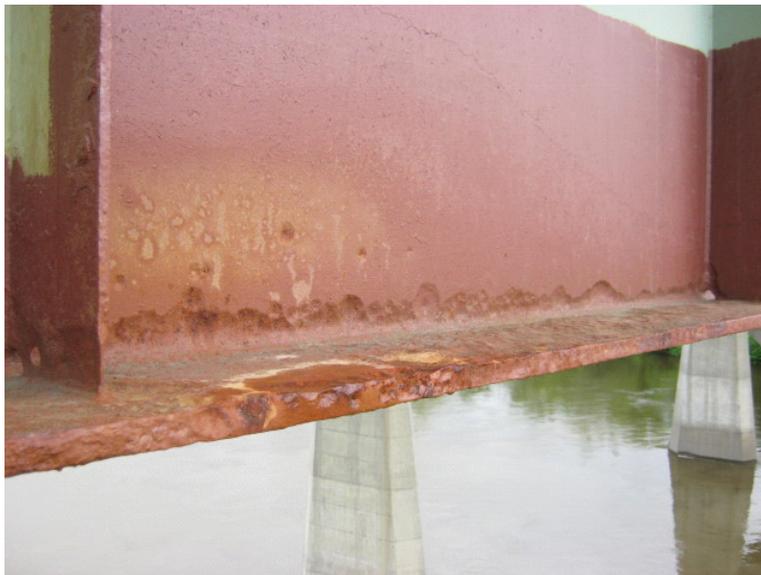
B467 05

GIRDER 1 SPAN 4.

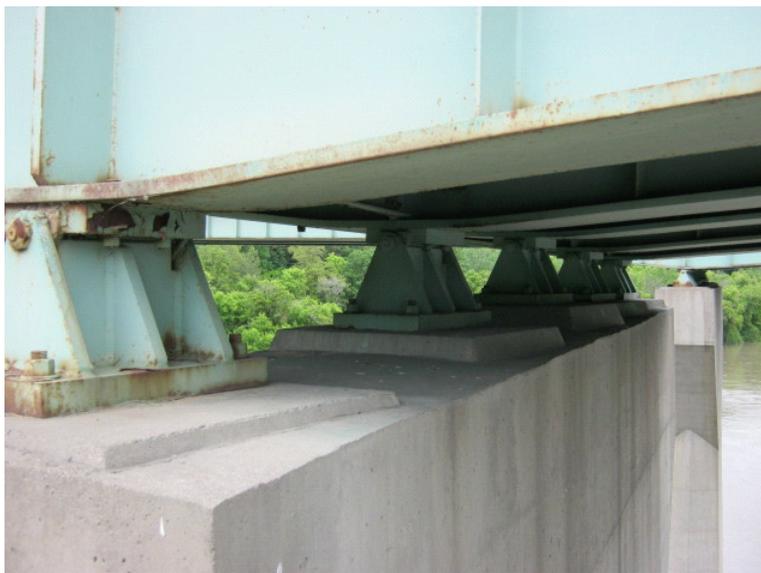
B467 06

BEARINGS PIER 3.

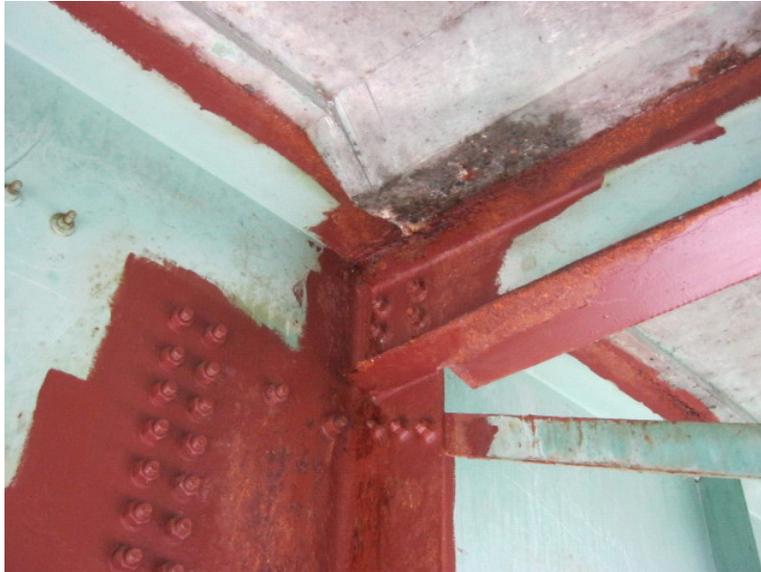
B467 07

RELIEF JOINT 1 LEAKING AT
BAY 1.

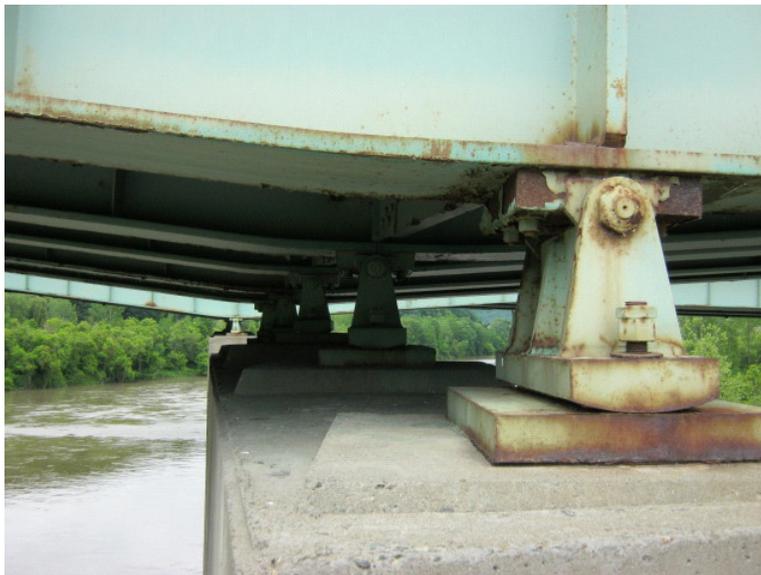
B467 08

BEARINGS PIER 2.

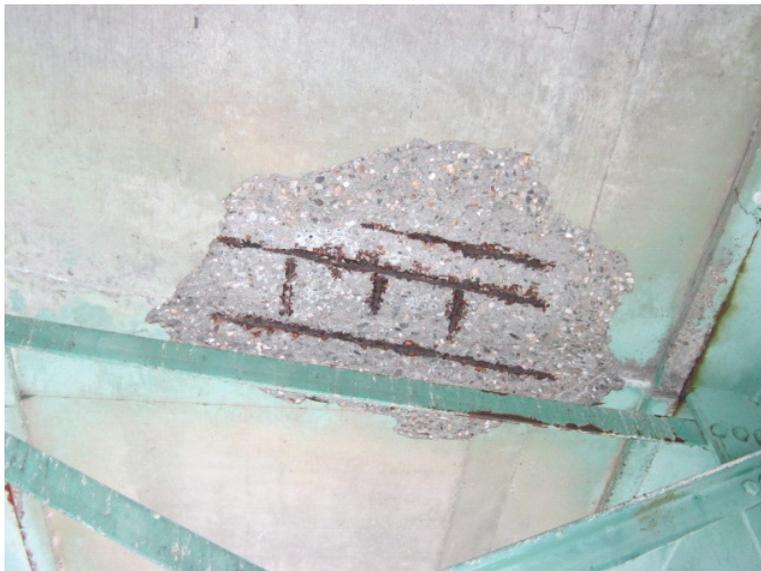
B467 09

LARGE SPALL IN BAY 2
SPAN 2.

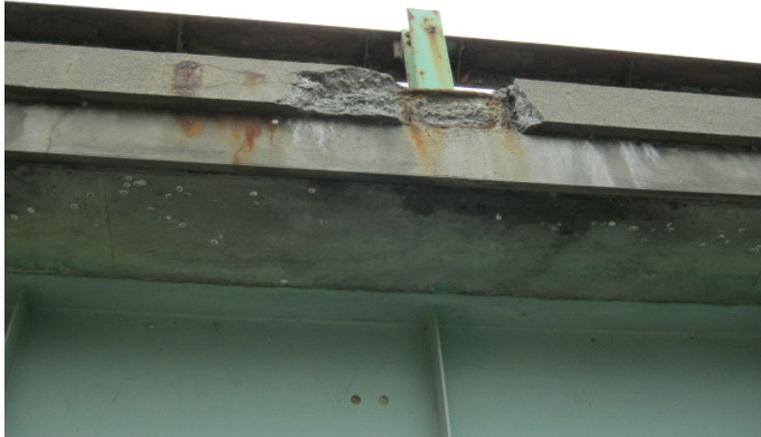
B467 10

CURB SPALLED AT WEST
REBAR EXPOSED.

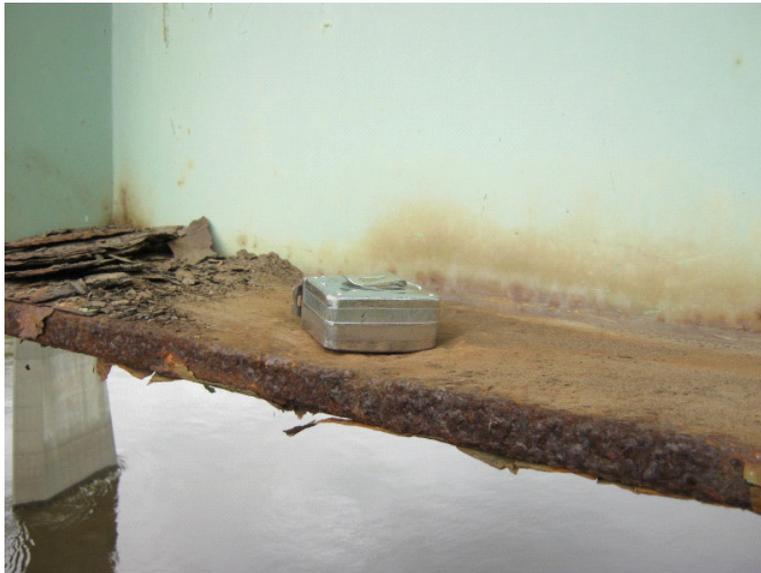
B467 11

GIRDER 1 SPAN 2 BOTTOM
FLANGE RUSTED WITH UP
TO 1/4" SECTION LOSS.

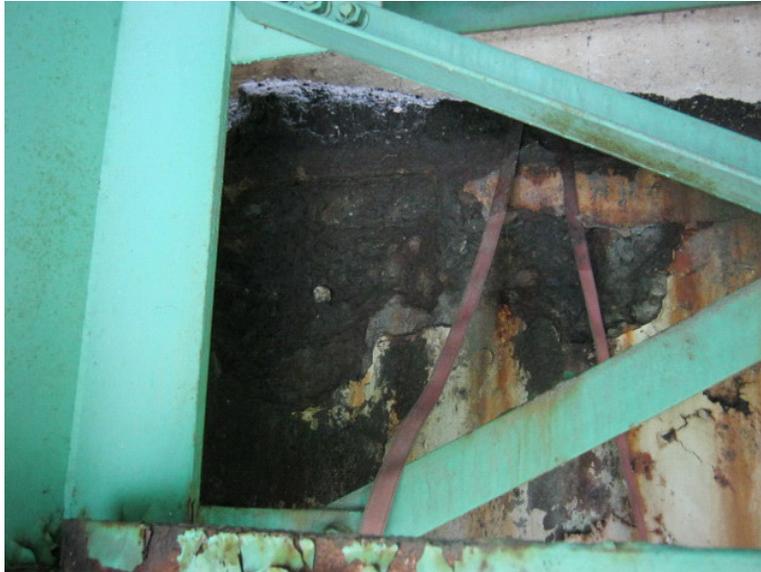
B467 13

LARGE SPALL AT SOUTH
BACKWALL.

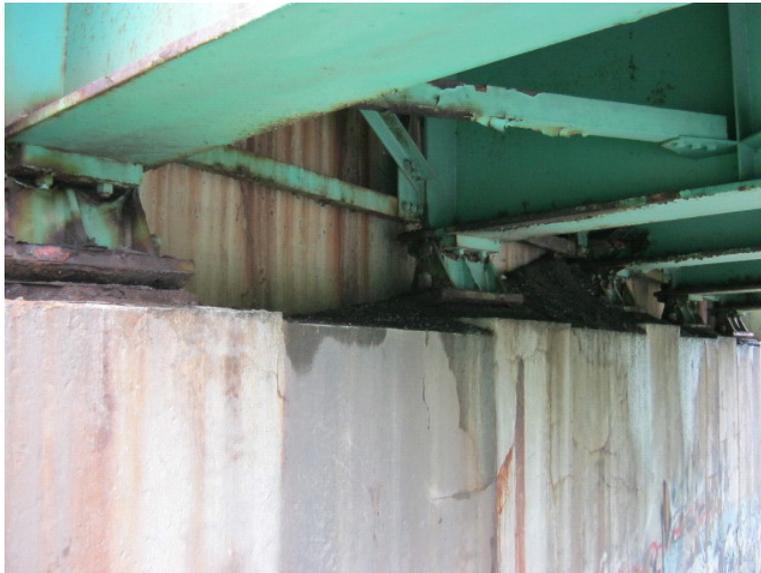
B467 14

BEARINGS SOUTH
ABUTMENT.

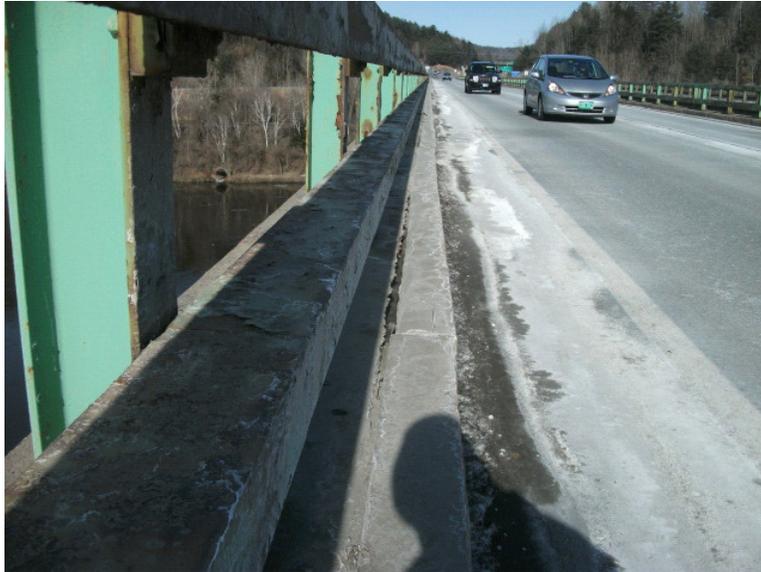
B454 92

SPALLS BEHIND GRANITE CURBSTONES.

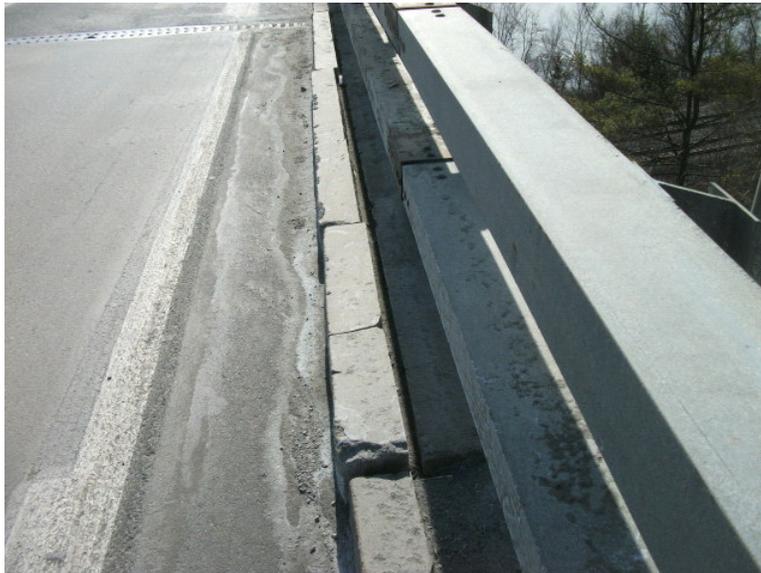
B454 93

GRANITE CURBSTONES
CRACKED AND TIPPED AT
NORTHWEST.

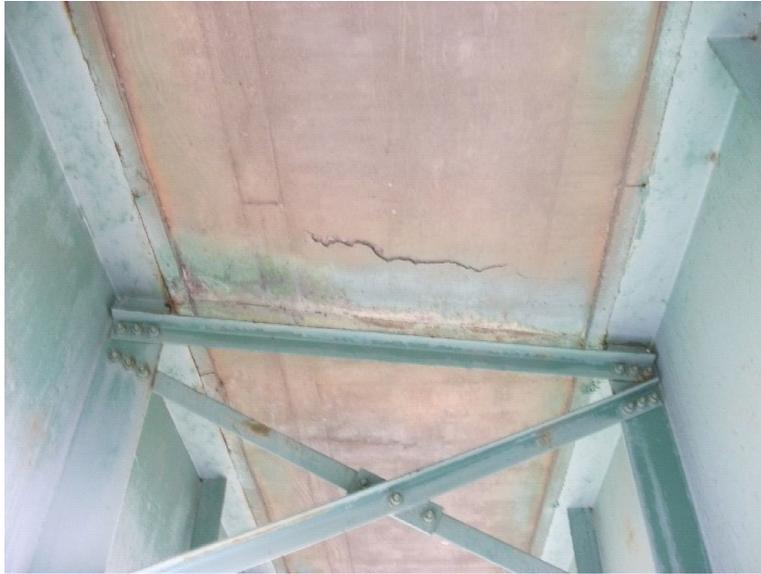
B431 18

DELAMINATION IN BAY 3
SPAN 5.

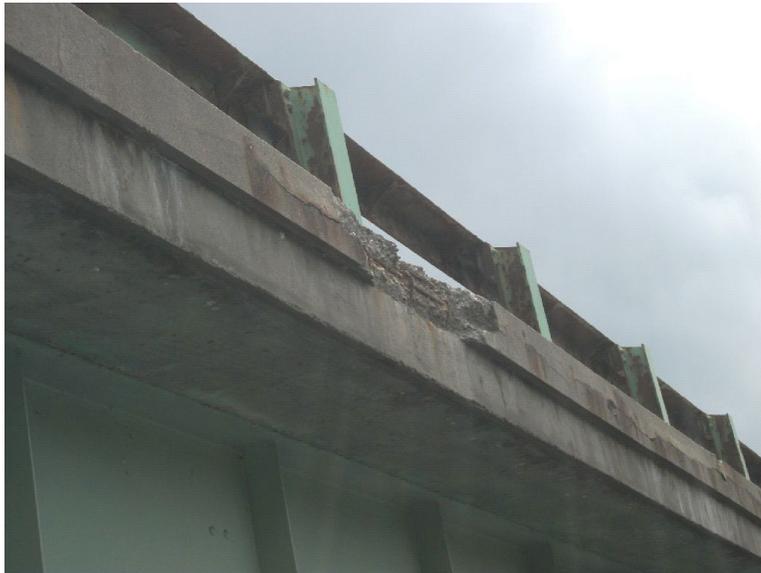
B431 19

CURB SPALLED AT WEST.

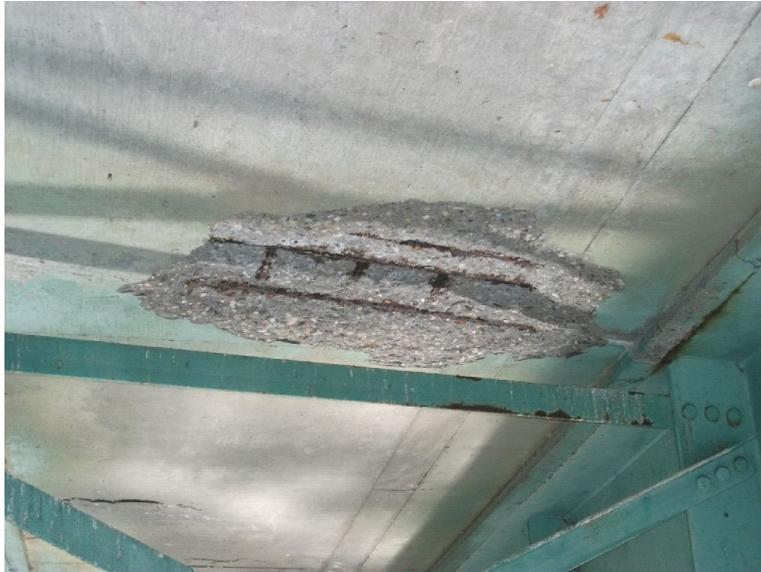
B431 21

SPALL WITH REBAR
EXPOSED SPAN 2 BAY 2.

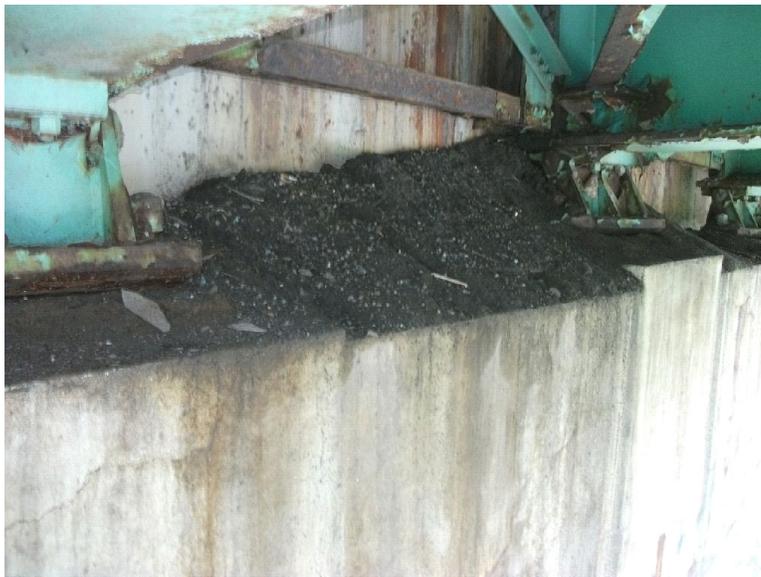
B431 22

BEARINGS # 3,4 DEBRIS
COVERED ON SOUTH.

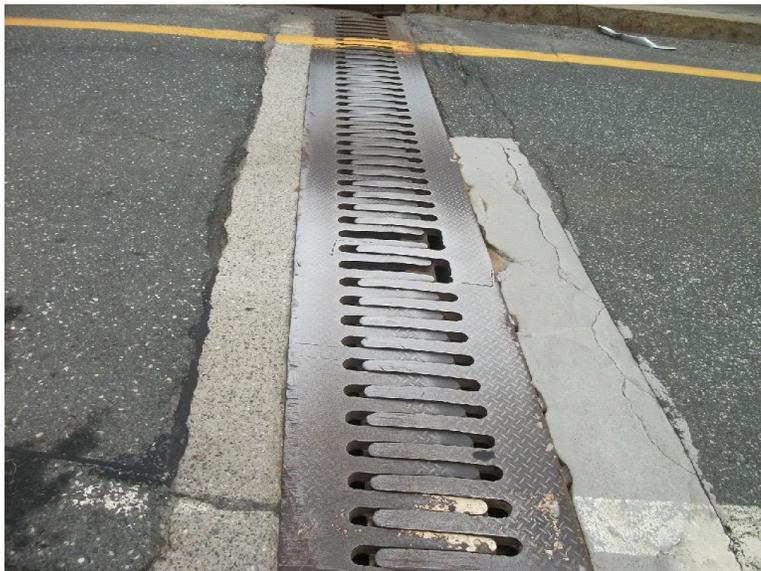
B431 23

JOINT AT SOUTH BROKEN
AND SLAPPING.

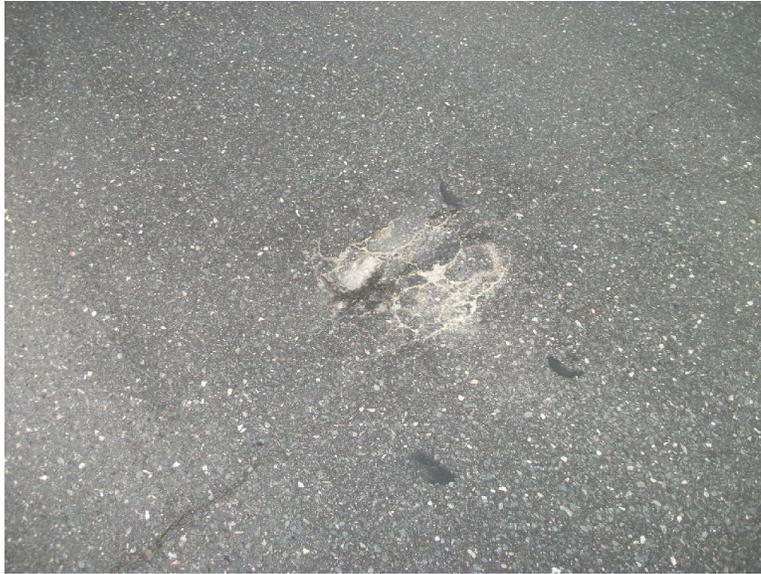
B431 24

ASPHALT POTHOLED AT
SOUTH IN SPAN 3.

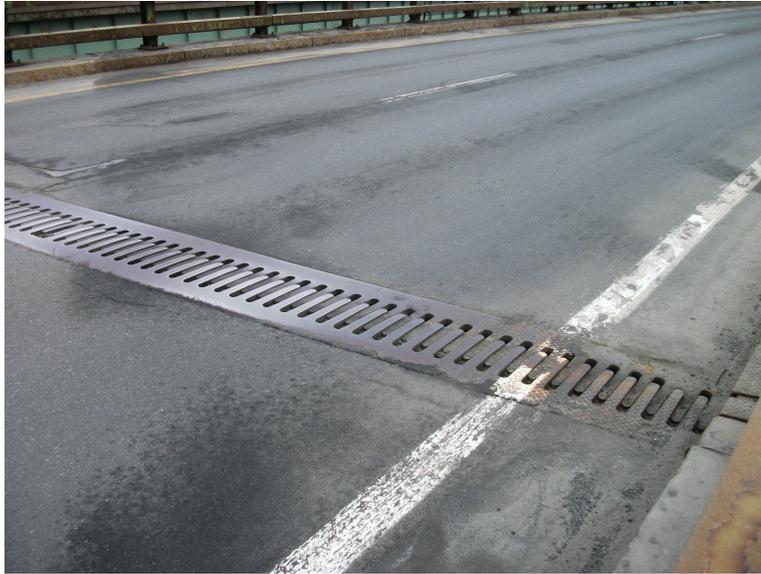
B423 38

DEPRESSION IN TRAVEL
LANE AT NORTH. (SRL).

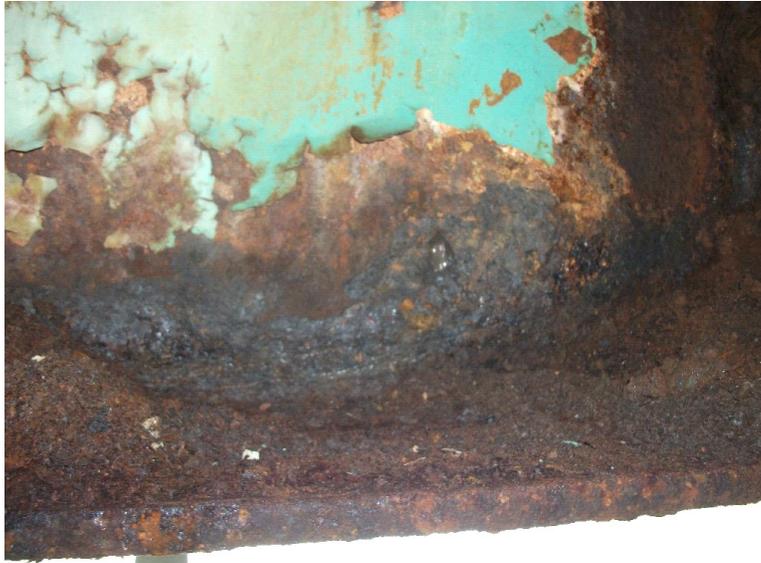
B417 36

BEAM #4 SPAN 3 RUST AND
PITTING.

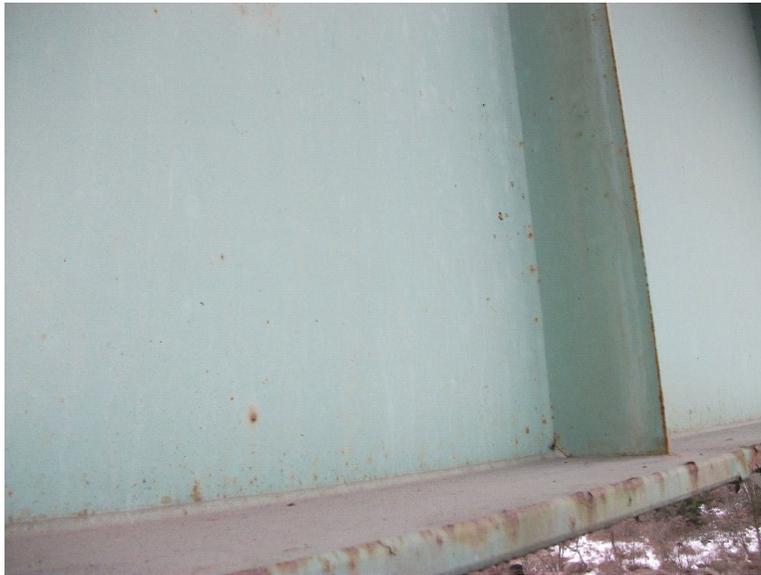
B417 37

BEAM 5 SPAN 3 EXTERIOR
SIDE.

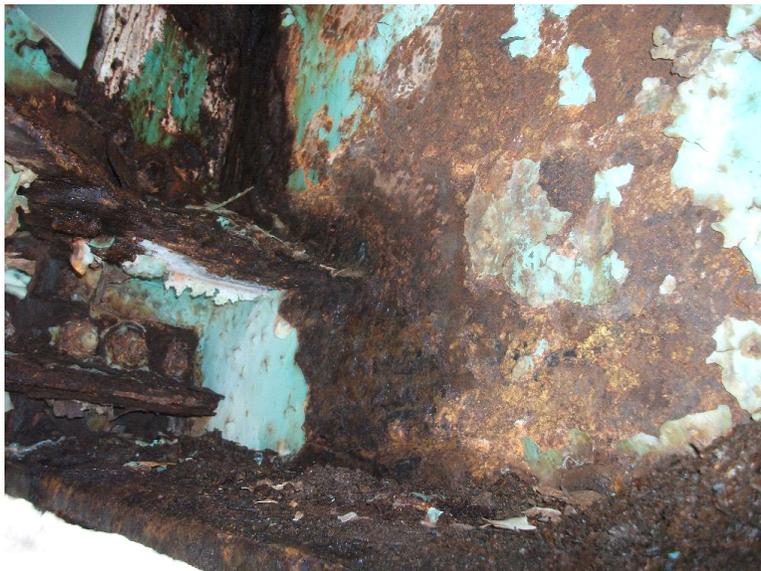
B417 38

BEAM 5 SPAN 3 INTERIOR
RUSTED AND PITTING.

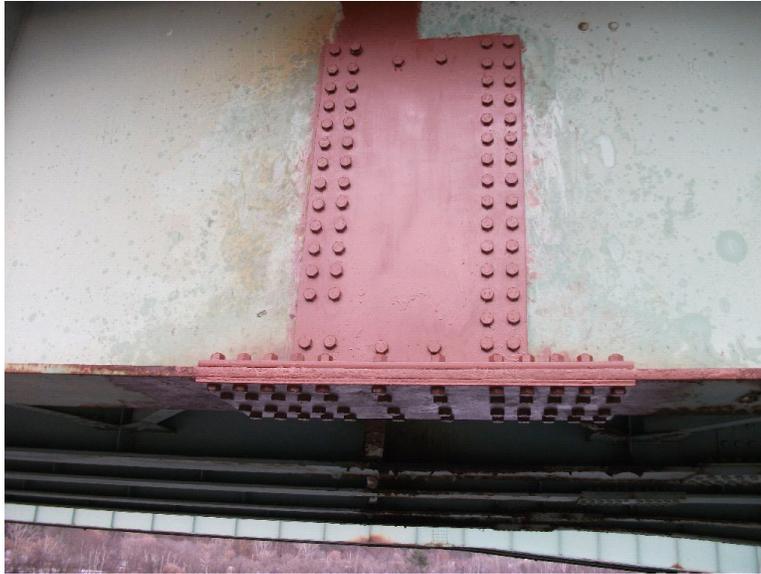
B417 39

REPAIRS AT BEAM 1 SPAN 3
EXTERIOR WEB.

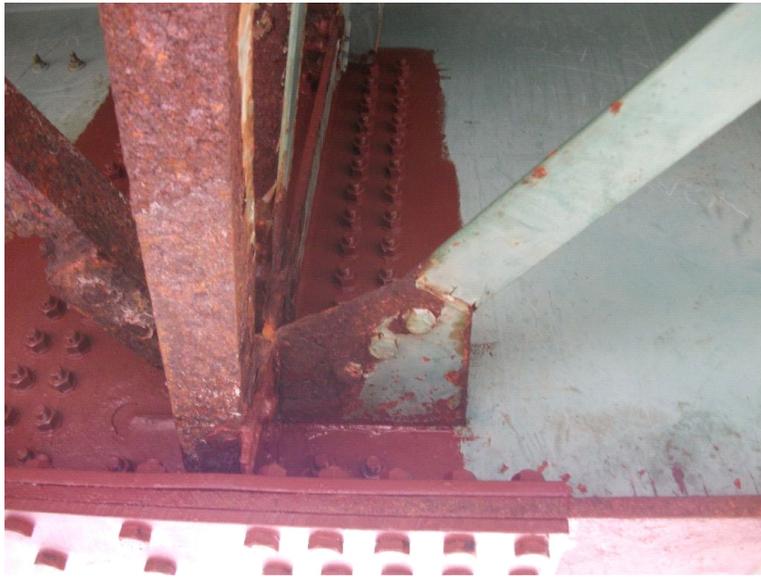
B417 40

REPAIRS AT BEAM 1 SPAN 3
INTERIOR WEB.

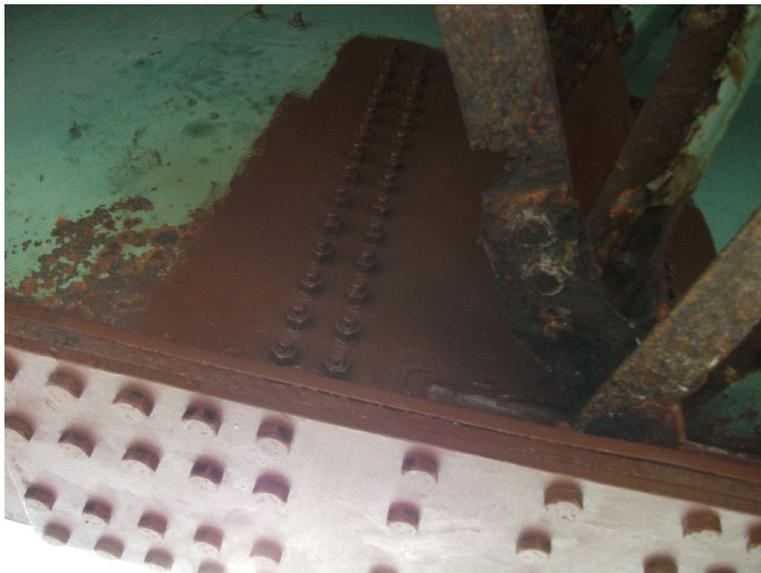
B417 41

REPAIRS AT BEAM 1 SPAN 3
INTERIOR WEB.

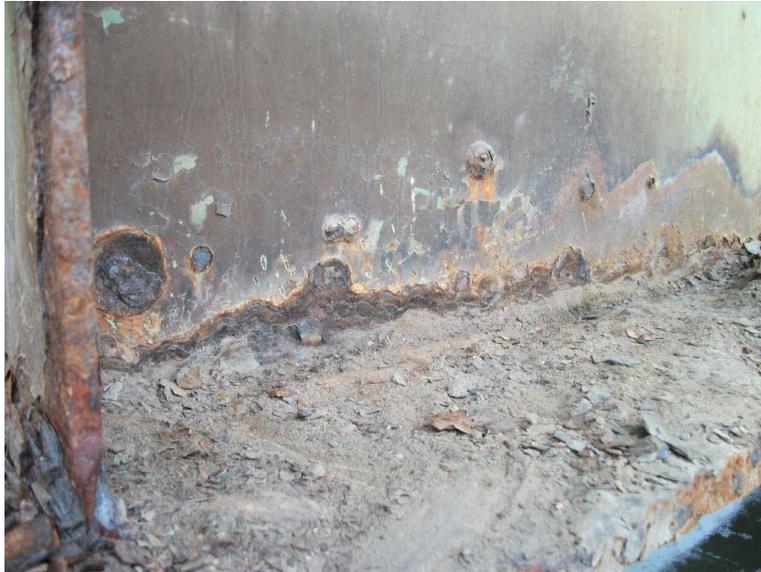
B417 42

BEAM 1 SPAN 4 EXTERIOR
WEB RUSTED AND PITTING.

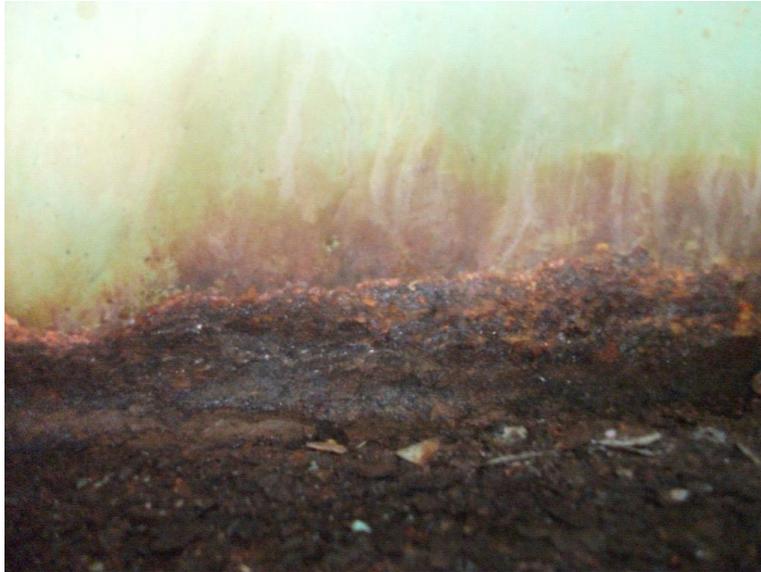
B417 45

BEAM 5 SPAN 4 RUSTED
AND PITTING.

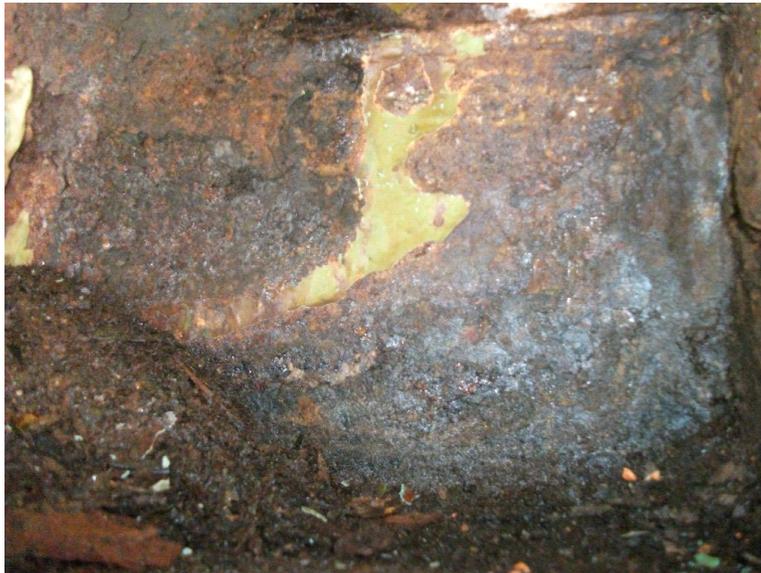
B417 46

BEAM 5 SPAN 4 RUSTED
AND PITTING.

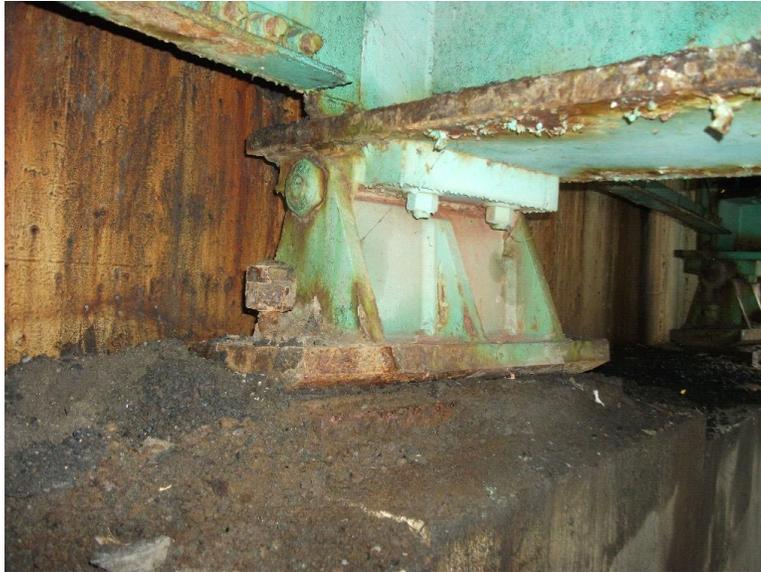
B416 64

BEARING #4 AT NORTH
ABUTMENT, NUTS RUSTED
AND BOLT LIFTED.

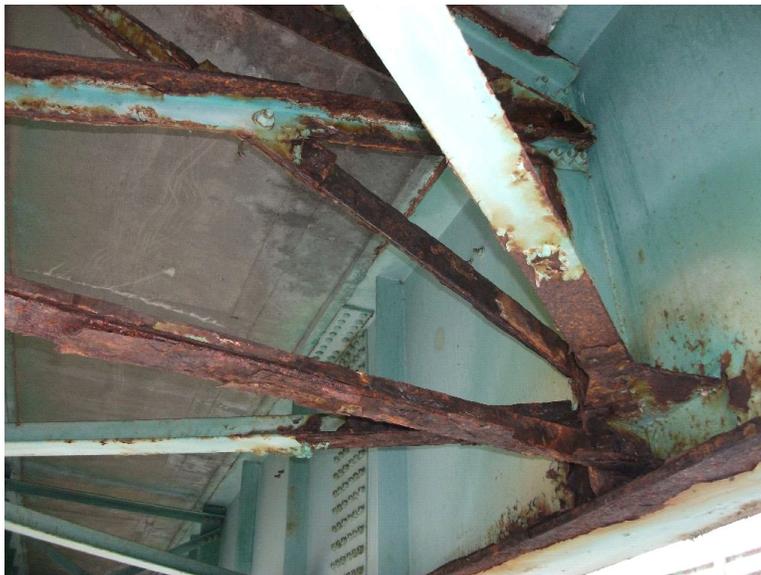
B416 65

CROSS BRACING RUSTED
AND HOLED AT #5 GIRDER,
SPAN #4 UNDER RELIEF
JOINT.

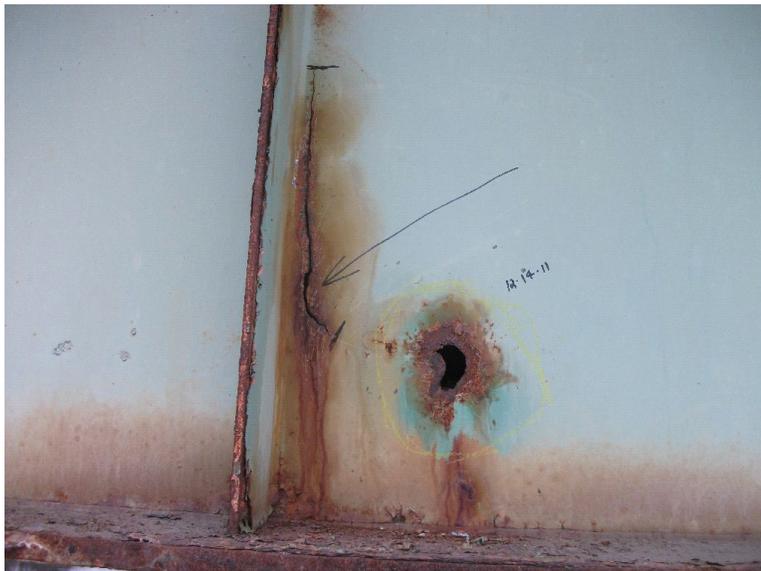
B416 66

16" VERTICAL CRACK
ADJACENT TO 1 1/2 BY 2 1/2
HOLE IN WEB OF GIRDER #1
IN SPAN #3.
